RIPARIAN HABITAT EVALUATION

RAMIREZ CANYON PARK
CITY OF MALIBU, CALIFORNIA

LSA Project No. SMM032

August 30, 2002

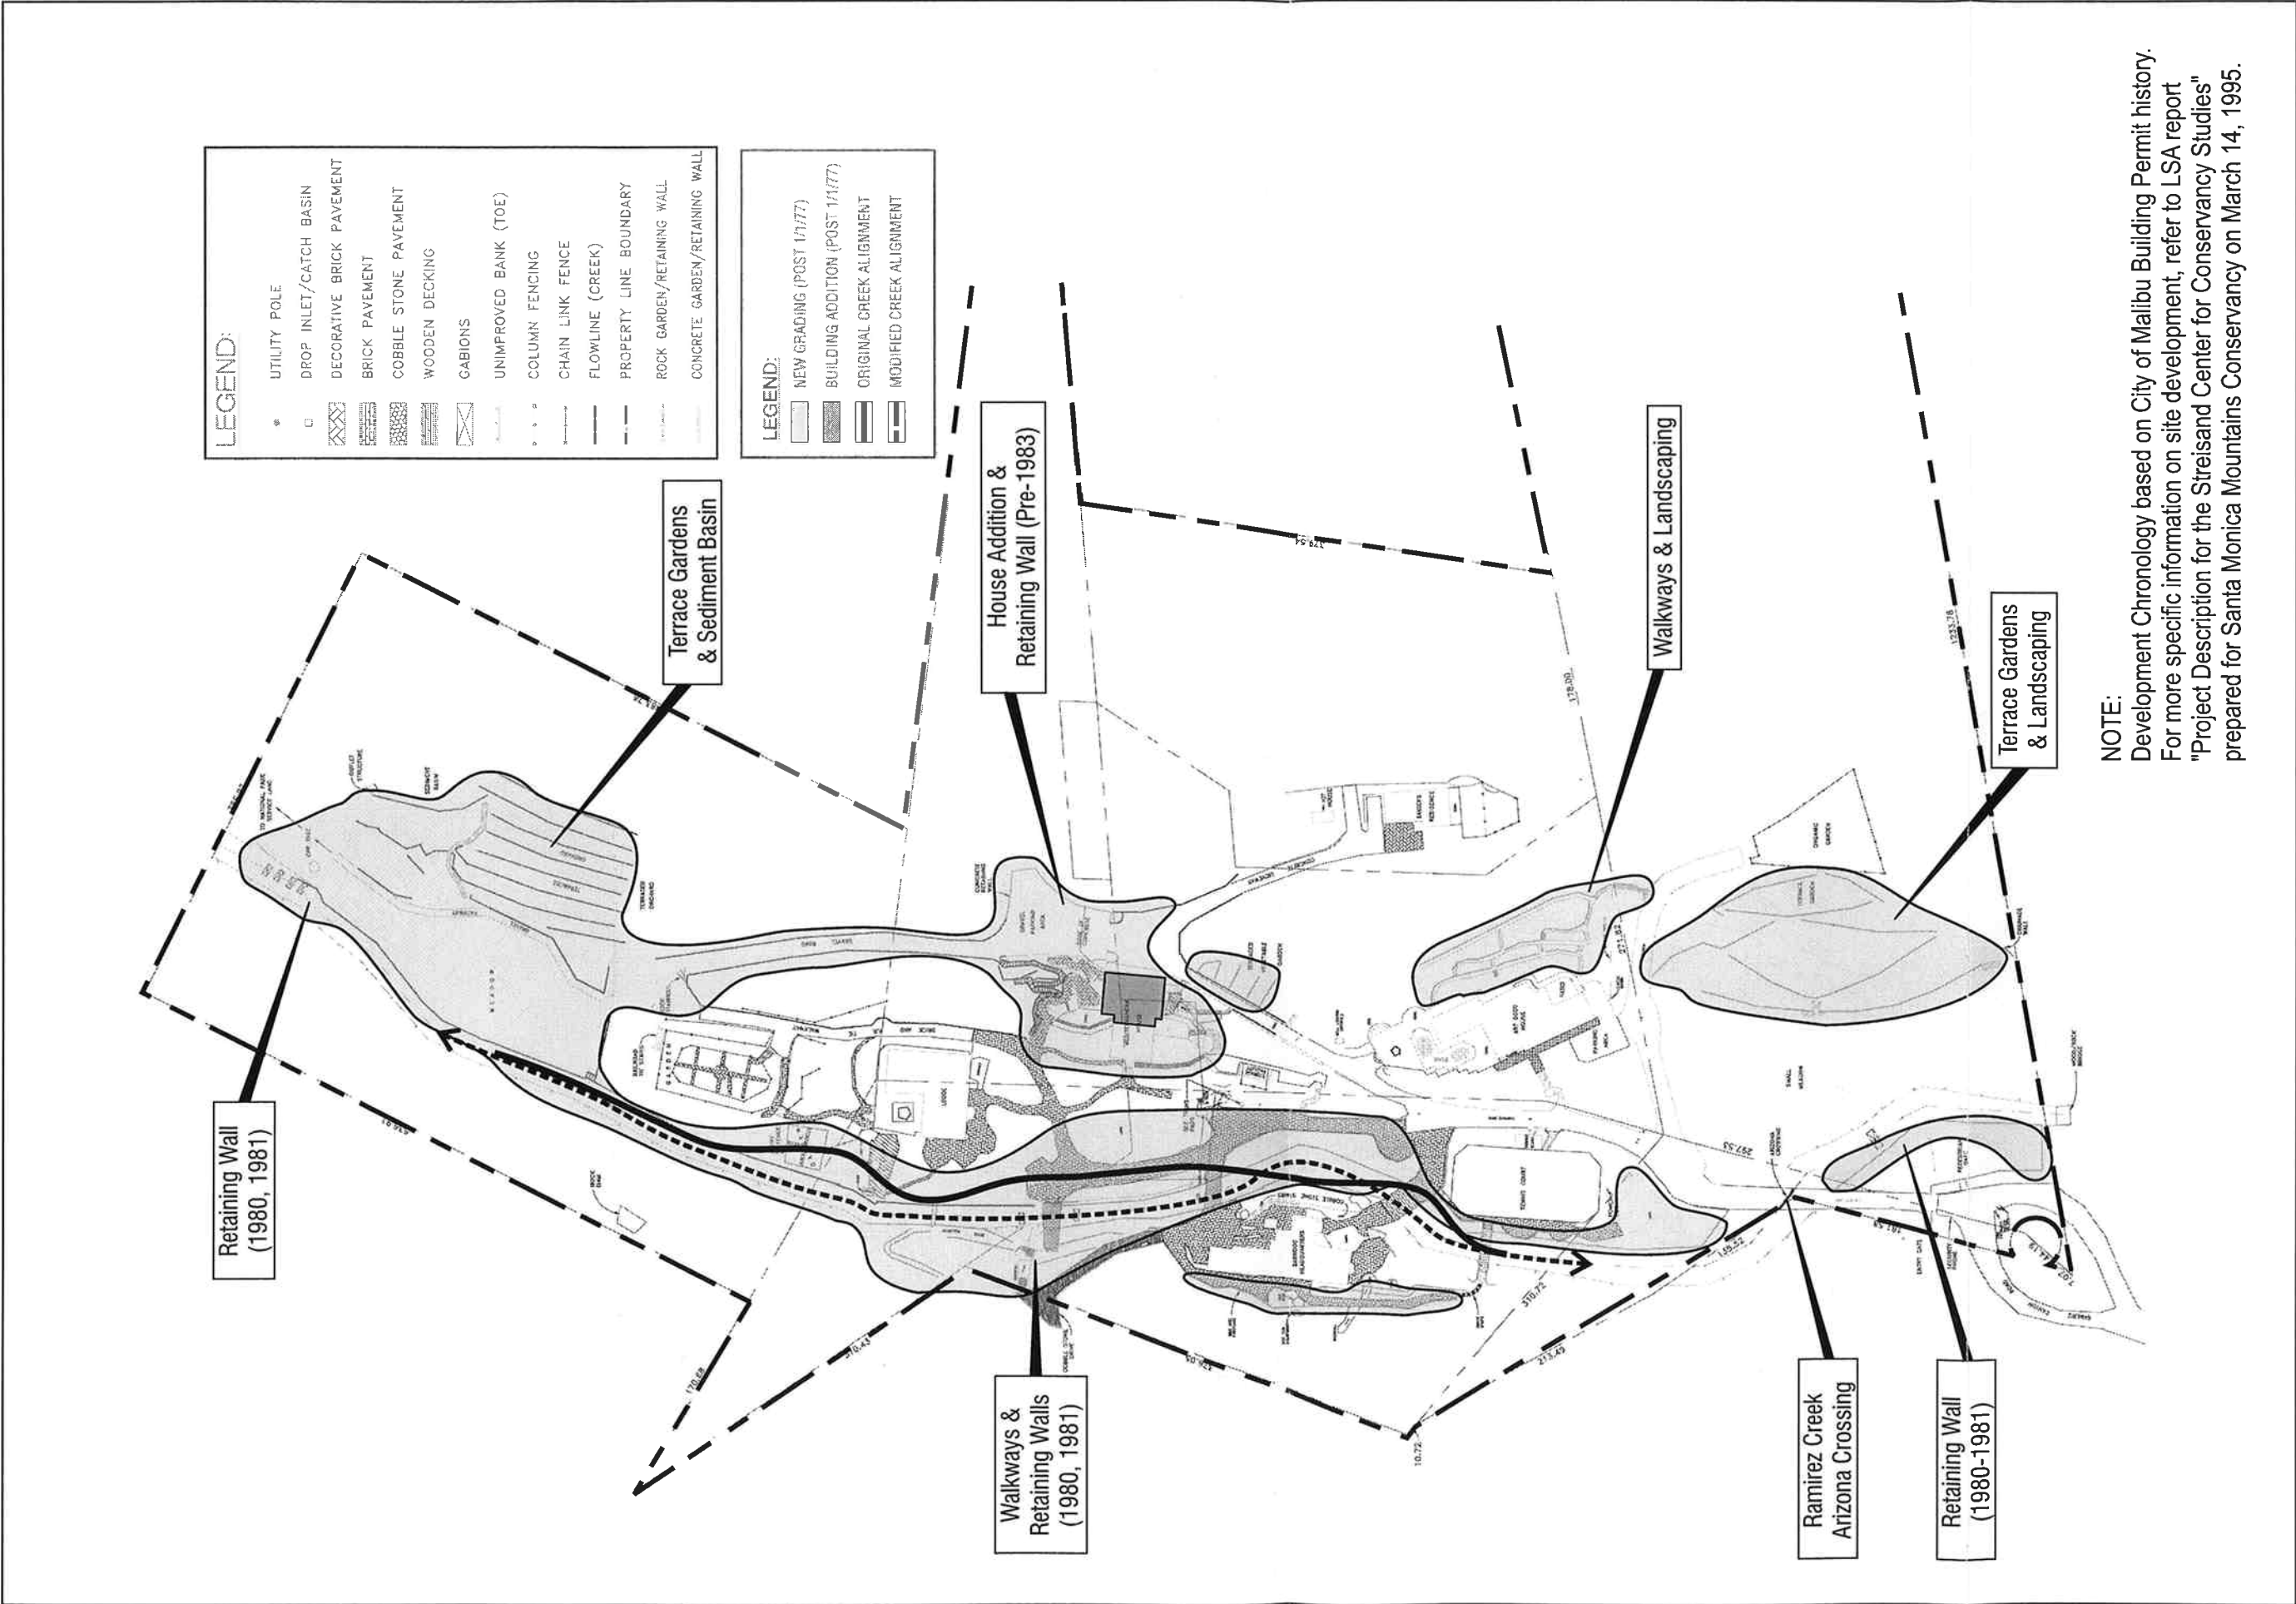
FIGURE 3

After January 1, 1977, the riparian habitat at the Park was disturbed by the installation of rock walls along the previously impacted 1,600-foot creek channel adjacent to the residences and meadow. These additional impacts occurred during the early 1980s (LSA, 1995b). The Park was extensively landscaped. Dense vegetative cover was present in 1994 when the property was donated to the SMMC and can be seen in the 2001 aerial photograph (Figure A3).

The modification of the stream channel, temporarily impacted water quality and permanently impacted the flood attenuation function of the creek channel. With the installation of the rock walls, stream discharge rates increased due to the loss of infiltration into the surrounding areas and loss of dissipation by vegetation growing near the channel. In order to counteract the adverse hydrological effects of the solid drainage structure, gabions were installed in conjunction with the wall construction. A total of nine gabions (or check dams) were placed in the creek channel. The purpose of the gabions was to intercept storm runoff, attenuate stormwater runoff, and retain sediment.

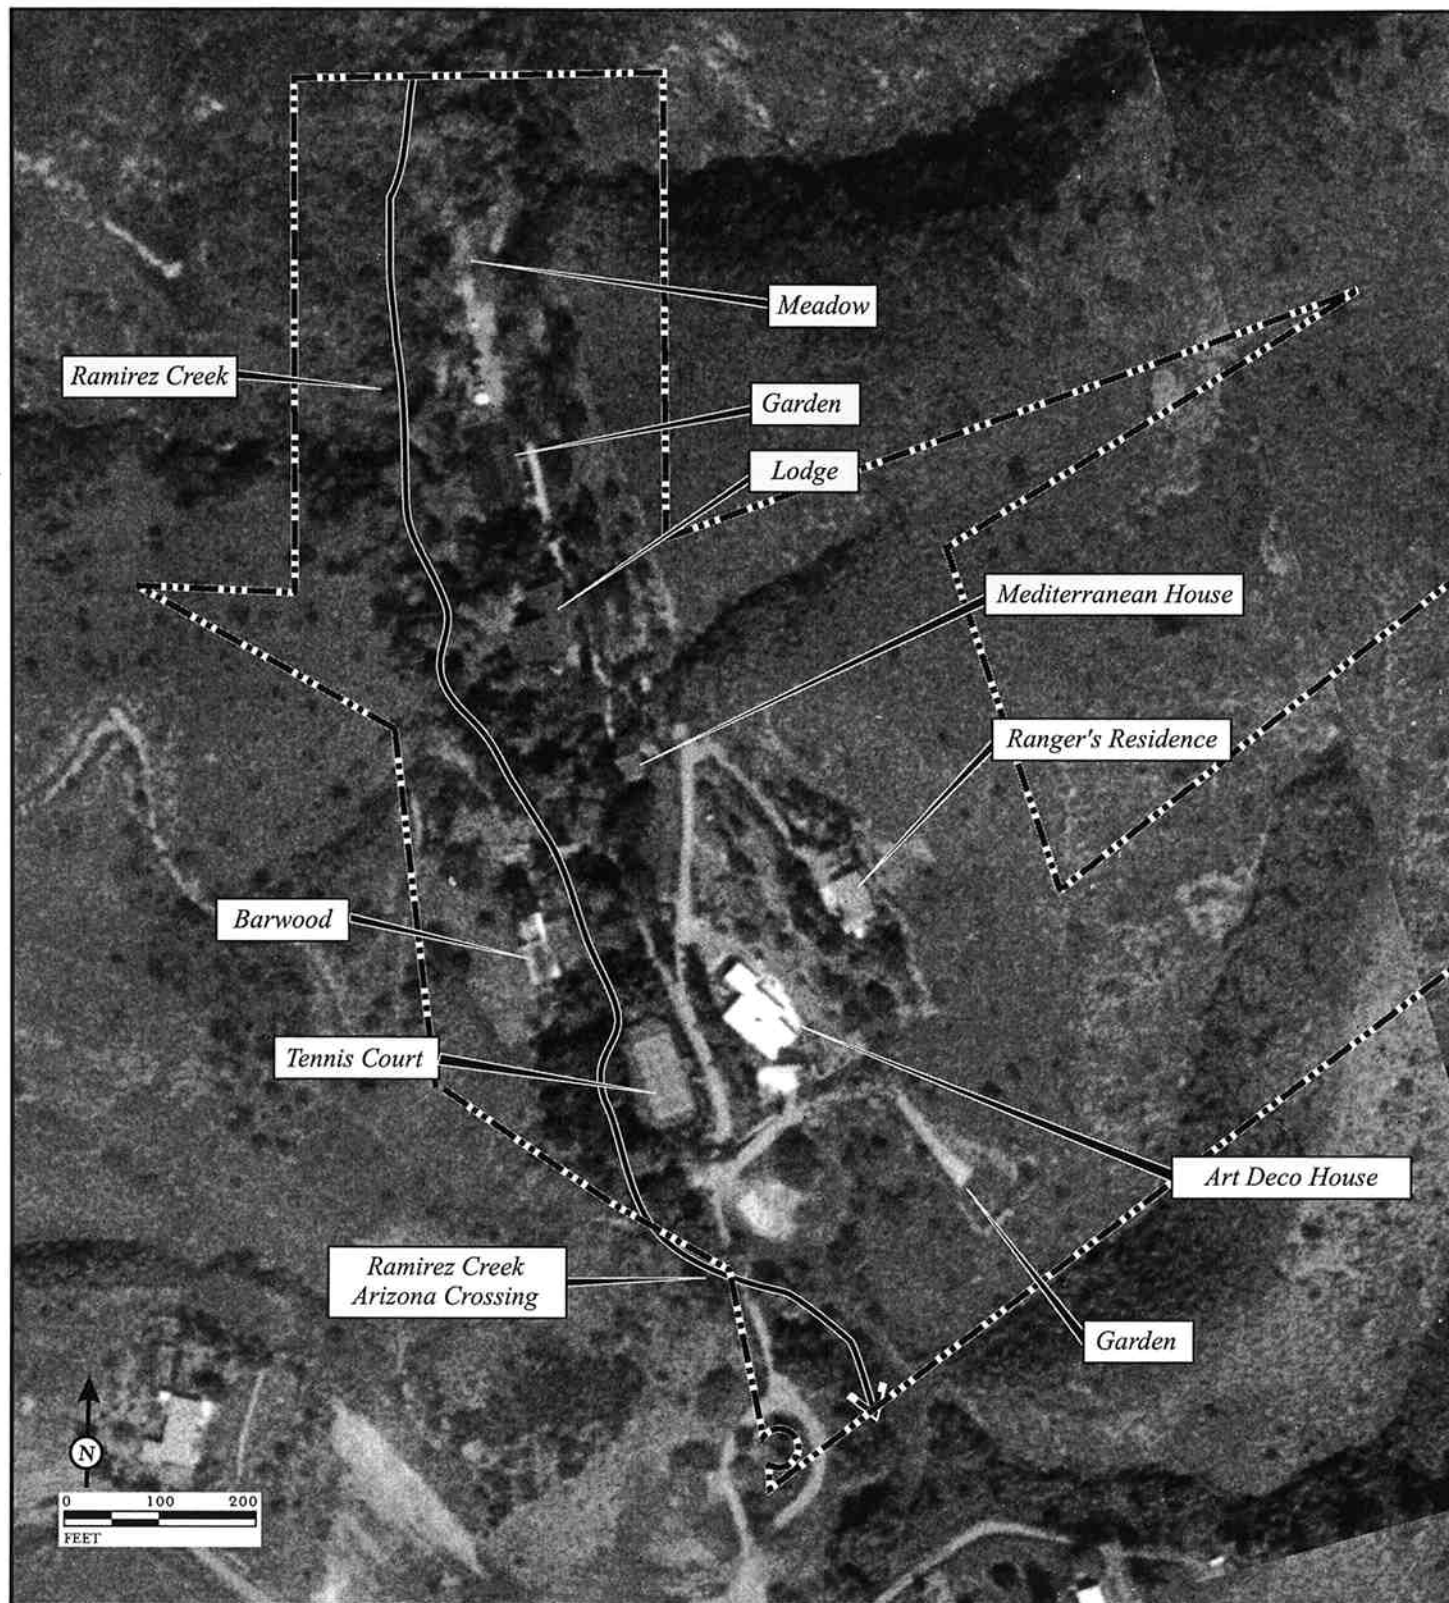
FIGURE A2

As shown in the 1976 aerial photo, the vegetation of the site is naturally sparse except for the riparian vegetation in the stream channel. The vegetation of the site was altered on the canyon slopes and up to the creek edge to build the residences and infrastructure. All native plants adjacent to the creek channel were disturbed and the vegetation removed from the development sites, roads, and meadow area. The majority of the riparian vegetation was cleared along the creek adjacent to the garden and meadow area (see 1975 aerial photograph). The mature riparian trees appear not to have been removed from the creek area, as they are visible in all the aerial photos. Thus, the functions and values of the riparian habitat were diminished by the development of the site prior to 1977. Plant and animal habitat was permanently altered and ecosystem productivity reduced due to the continued human presence and alteration of the landscape at the Park.
